# Building Collapse: Factors and Resisting Mechanisms, a Review

<sup>[1]</sup> Genevieve D. Fernandes, <sup>[2]</sup> Dr. Nisha P. Naik

<sup>[1]</sup> Student, Civil Engineering Department, Goa College of Engineering, Goa, India.

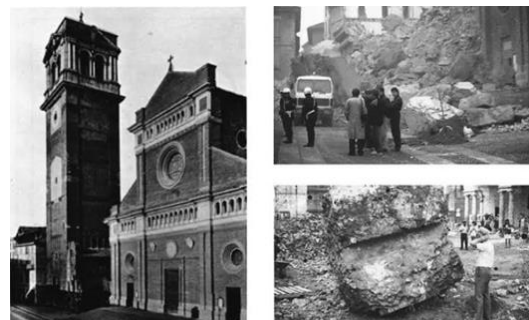
The civic tower of Pavia built in 1060 collapsed in a matter of minutes in 1989. The investigations revealed several causes like the time dependent behavior of the rubble and mortar concrete caused creep over the years, this action resulted in lateral expansion of concrete leading to the bursting of the brick skin, weakening the structure to such an extent that it spontaneously collapsed, the industrial air pollution around accelerated the weakening of the compressive resistance of the lime concrete. Another cause was the belfry construction over increased the tower height and consequently the wind forces on it, it increased the dead load, dangerously increasing the compressive stresses in the weakened concrete [1]. Summarily the collapse of this tower can be attributed to degradation of material over the years or collapsed due to old age.

Fig 1: Tower of Pavia [2]

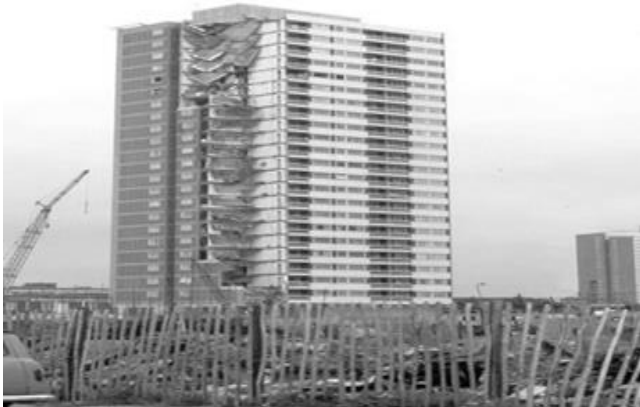
Ronan Point- a 22 storey precast apartment tower building collapsed partly within three months of its service life. The collapse was shocking to the engineering fraternity as it was initiated by a small gas explosion. The blowing out of an outer panel resulted in the loss of a bearing wall on the 18<sup>th</sup> floor initiating the collapse of all the upper floors. The collapse was attributed to its lack of structural integrity, there was no alternative load path for redistribution of forces on the onset of loss of bearing wall [3]. Therefore it led to the second phase triggering the collapse of 17<sup>th</sup> floor and below. The dynamic loading imparted by the falling debris resulted in the collapse of the south east corner of the building up-to ground level.

**Fig 2: Ronan Point apartment after collapse [4]**

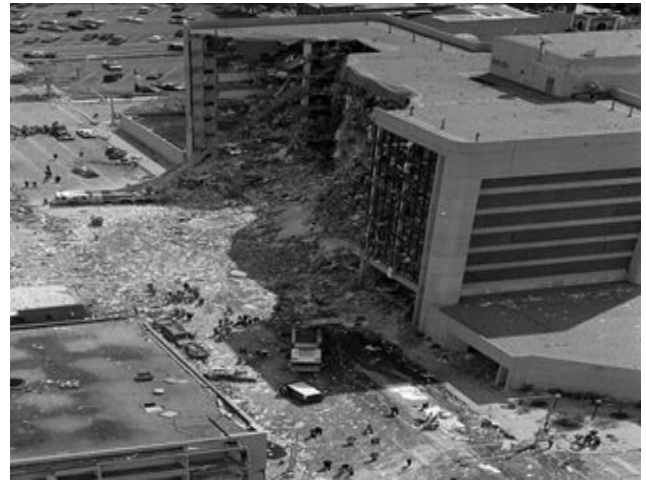
This building was an office facility for the US government situated in Oklahoma. It was a nine story building of reinforced concrete with ordinary moment resisting frame. This building was the target of a terrorist attack in which a truck bomb detonated in front of its north side. The explosion caused extensive structural damage which spread the entire width of the building. Three column which supported a transfer girder in the third floor were immediately destroyed by the blast triggering progressive collapse in the upper stories. The blast blew the granite panels of the infill walls from the 3<sup>rd</sup> to the 6<sup>th</sup> floor. The assessment team found that the removal of a column in the first would redirect additional loads to the laterally adjacent columns, exceeding their yield moment and shear capacity. The loss of these columns would leave the transfer girder only partially supported. The investigating team concluded that this ordinary moment frame could not sustain the level of ductility required to redistribute the loads with three columns missing in the first story [5]. The nearby buildings were too damaged due to the explosion.

**Fig 3: Alfred P. Murrah Federal after bombing [6]**

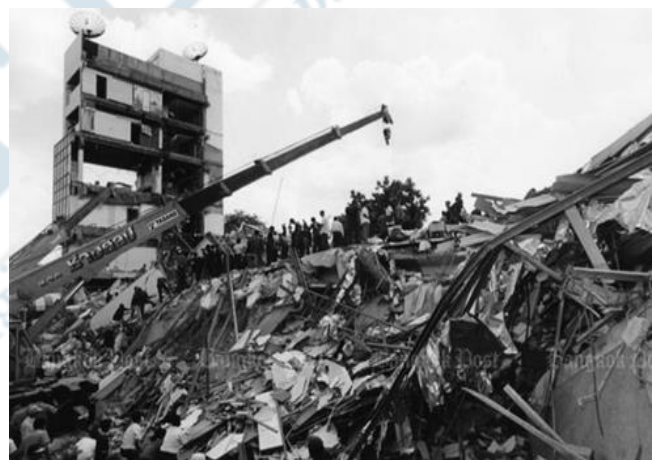
It is a six storeyed building in Korat. It collapsed vertically with little lateral displacement and the floor slabs stacked nearly one above the other. The collapse was due to addition of three extra stories. The original margins of safety incorporated on ground floor columns exceeded leading to their collapse.

**Fig 4: Royal Plaza Hotel collapse [7]**

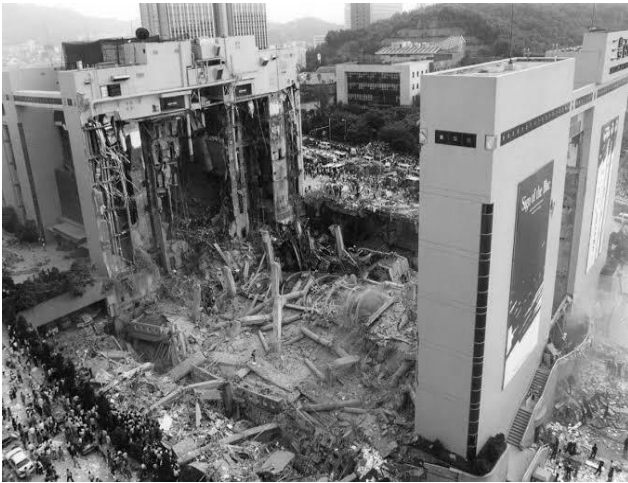
This building was initially designed for residential apartments which later converted to departmental store halfway through construction cutting away the number of support columns to install escalators. To maximise the floor space sizes of floor columns were reduced etc. In all this the personnel hired at different stages overlooked the ethical principles of engineering at the behest of the financier [8]. This structure collapsed in 1995, six years after its construction causing hundreds of deaths and injuring people.

**Fig 5:** Sampoong Department Store collapse [9]

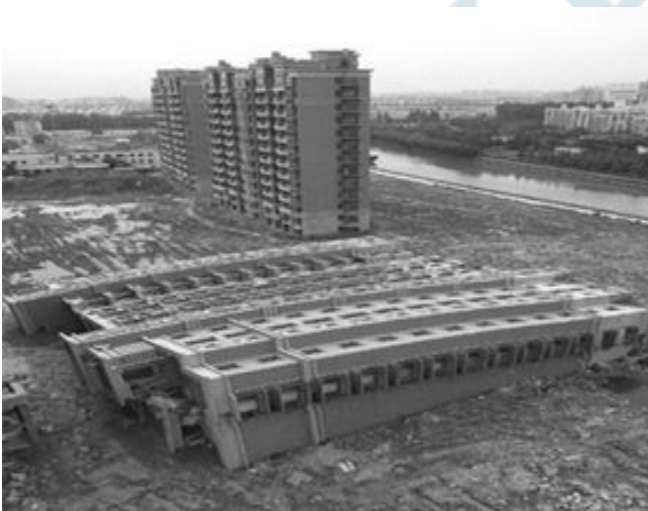
It is thirteen storey apartment building making up the Lotus riverside in Shanghai. It just fell flat on the ground in Jun, 2009 while it was still under construction. Fortunately all the workers escaped the site sensing its collapse. The reasons for the failure was that, the foundations were undermined by digging a pit of 4.6 m deep for underground car parking and dug out soil was piled 10 m high against one side of the building resulting in its collapse.

**Fig 6:** Lotus Riverside Compound Shanghai [10]

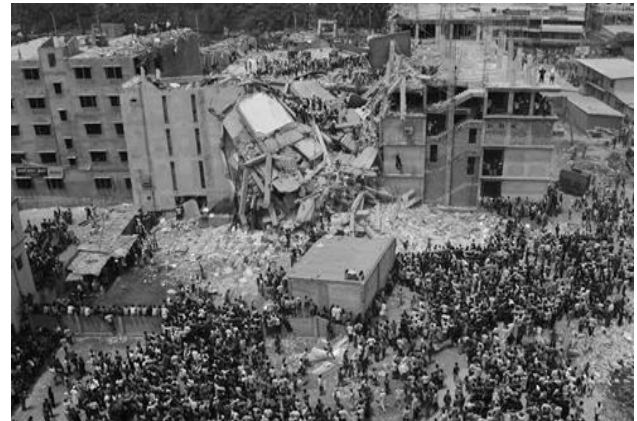
It is an 8 story commercial building called Rana Plaza. It collapsed leaving only the ground floor intact. The reasons for the collapse were its conversion from commercial to industrial use, it was built on a filled pond and three additional floors were added to the original plan.

**Fig 7:** Bangladesh Building Collapse [11]

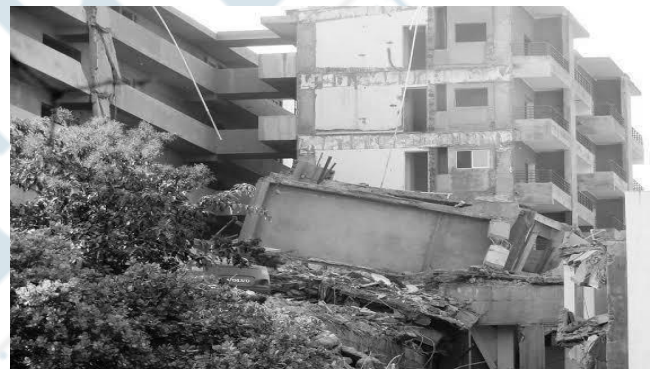
A six storied building collapsed at the fourth floor in 2014 while the construction of fifth floor was going on. The reasons for the failure include design of footing inappropriate for the filled area, bad design of columns, and defective execution of work at the site.

**Fig 8:** Residential building collapse [12]

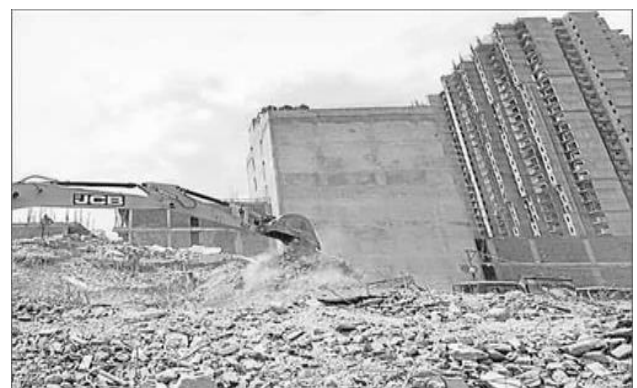
This building collapsed in 2018, a year after its construction due to water seepage. The investigations revealed poor quality of construction materials used like high water cement ratio i.e. low cement content in rubble and mortar, low grade of concrete, smaller diameter bars etc.

**Fig 9:** Greater Noida Collapse [13]
